Shearography for
Non-destructive Inspection
with applications to
BAT Mask Tile Adhesive Bonding and
Specular Surface Honeycomb Panels

by: Daniel B. Lysak

Technical Report No. TR 03 - 005
March 2003

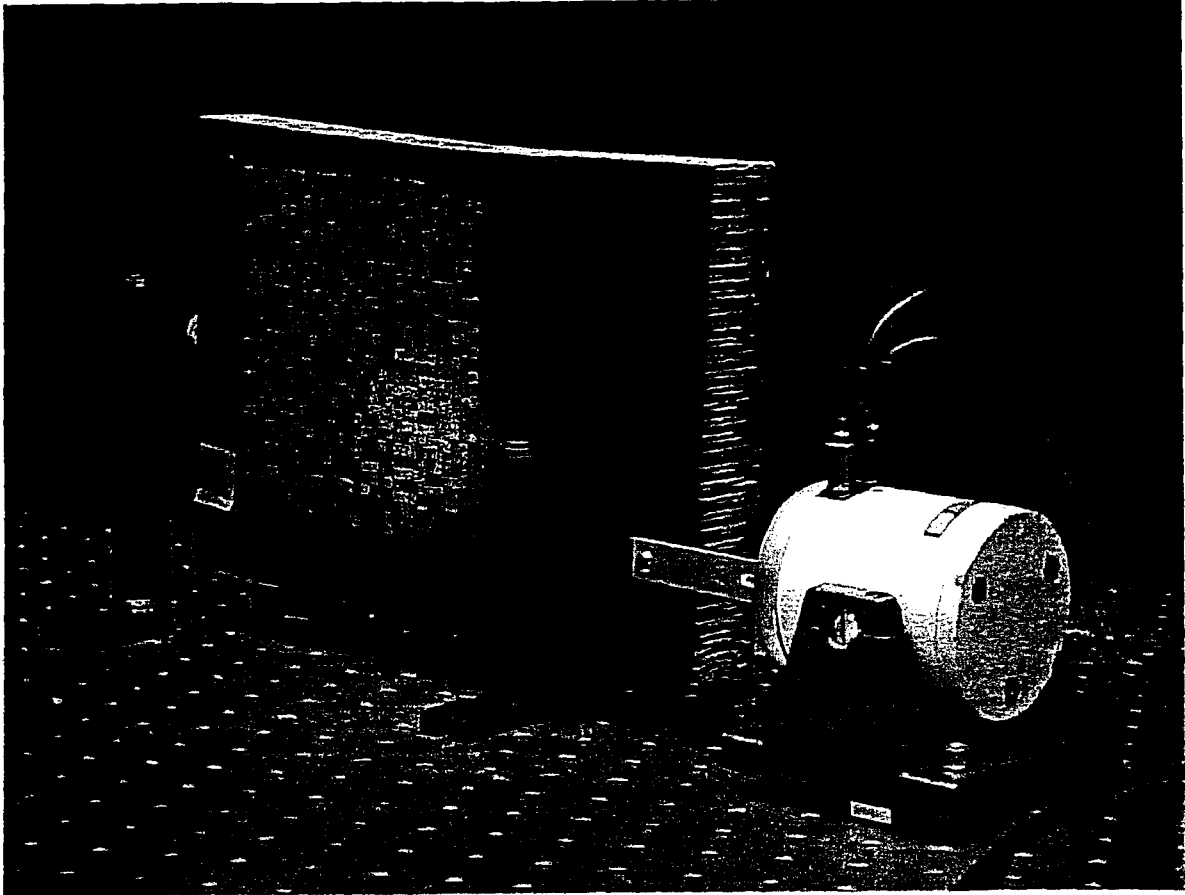
Figure 5. Portion of the BAT mask under test, illuminated by laser light and attached to a mechanical shaker. The tiles appear as a pseudo-random pattern of small gray squares. The orange spots are patches of adhesive where the tiles have fallen off.

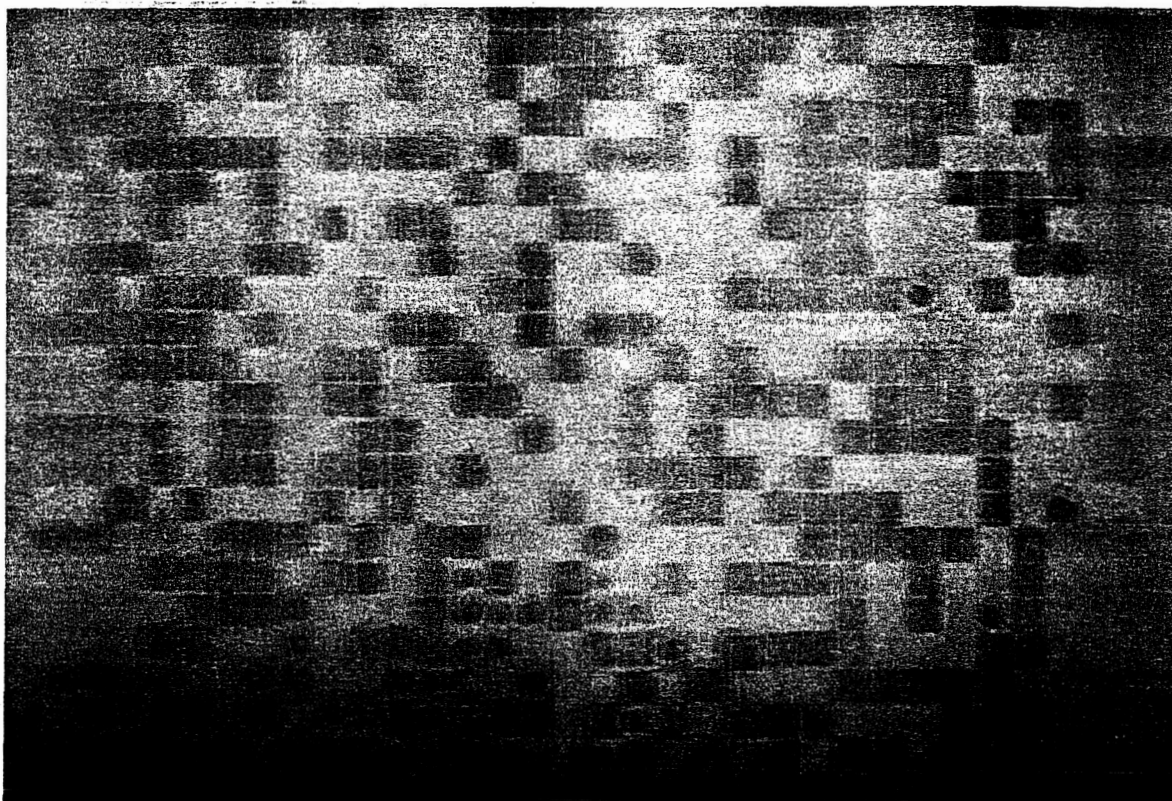
Figure 6. White light image of the BAT mask as seen through the interferometer by the camera. The image is sheared horizontally by about 1 mm making it appear blurred.

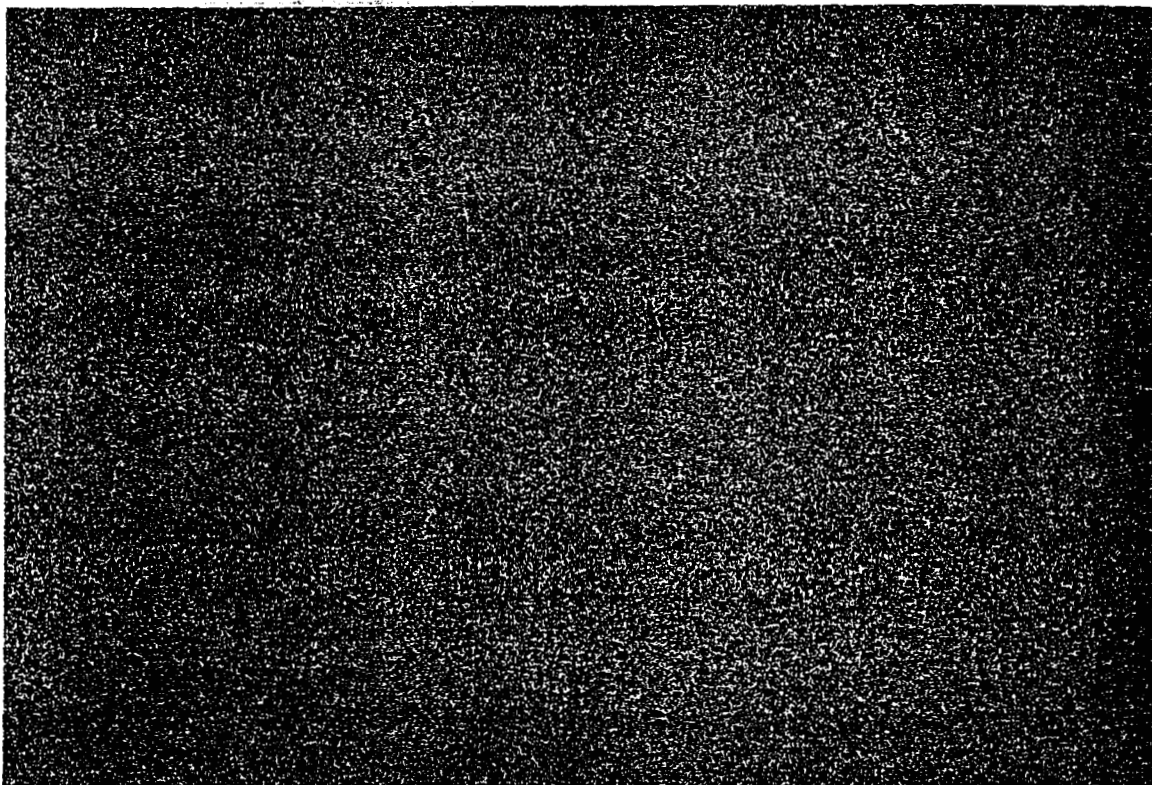
Figure 8. Typical speckle phase map computed from the four phase-stepped images. This is for the reference condition (120 degrees in the vibration cycle), but the phase map for the excitation condition has the same general appearance.

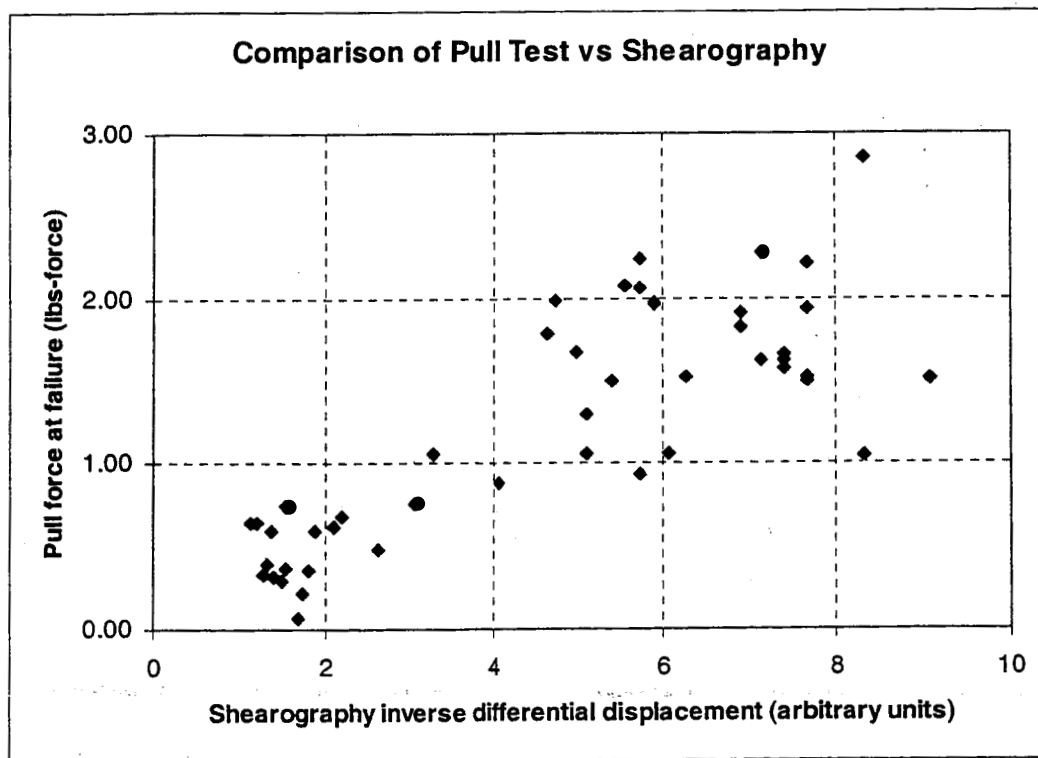
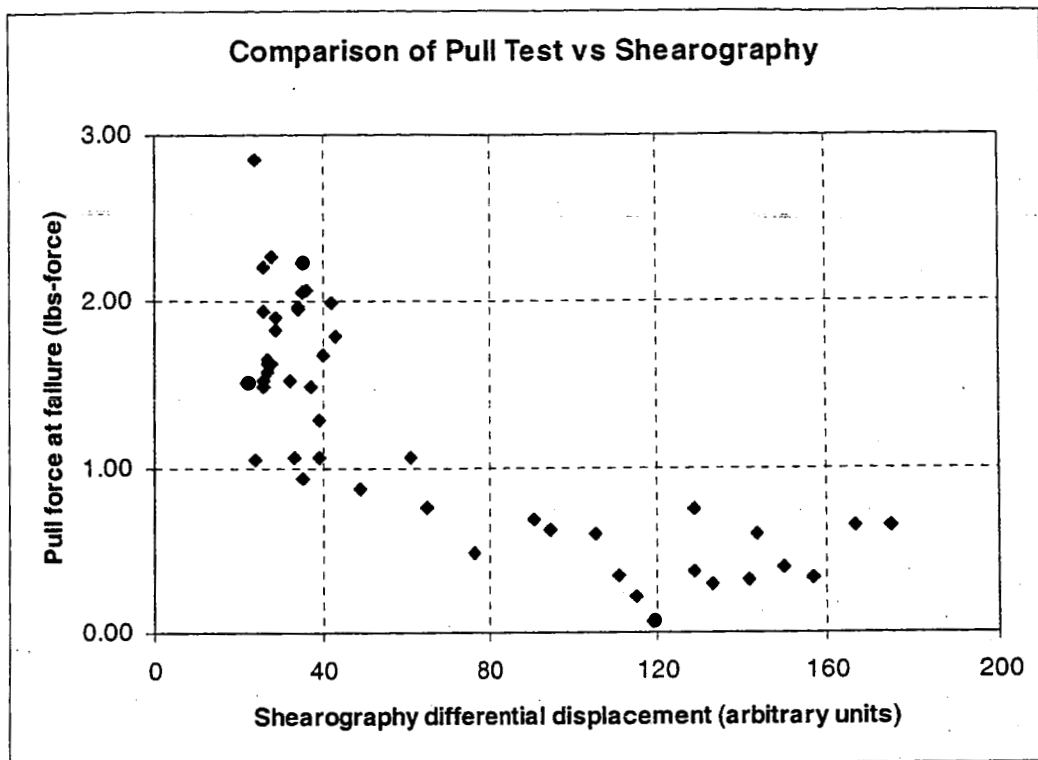
In many inspection applications, shearography is used to visually identify whether or not the object has failed, and all of the poorly bonded tiles stand out pretty clearly in Figure 9. In order to put the results on a more quantitative basis, a pull test was performed on a number of tiles for comparison with the shearography results. To assure a straight pull, a flat head nail was attached to the tiles with super glue as a pull mechanism. As each tile was pulled to failure, the force was measured with a load cell and automatically stored on computer for analysis. The test set up is shown in Figure 10.

Figure 9. Differential displacement, computed by taking the difference between the reference and excitation speckle phase maps (120 and -60 degrees in the vibration cycle, respectively). The tiles that have the greatest range of motion stand out against the relatively uniform dark background. The vibration frequency is 180 Hz.

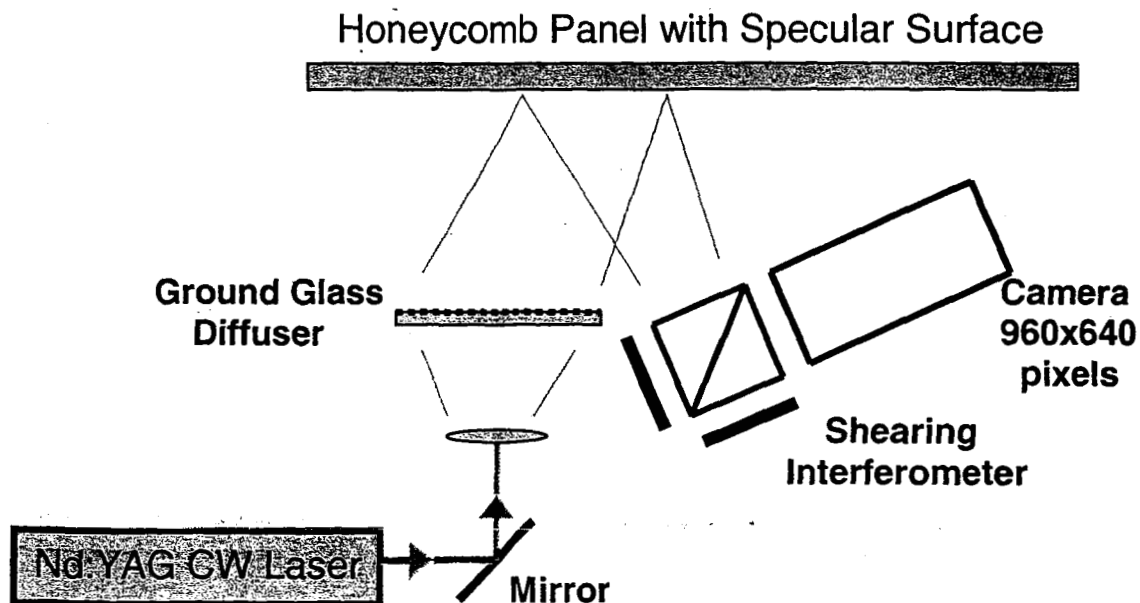
Figure 12. Specular surface honeycomb panel test configuration. The speckle is generated by passing the laser light through the ground glass diffuser and imaged using the specular surface as a mirror.
